REPORT DOCUMENTATION PAGE		READ INSTRUCTIONS BEFORE COMPLETING FORM
1. REPORT NUMBER	2. GOVT ACCESSION NO. AD-A105782	3. RECIPIENT'S CATALOG NUMBER
4. TITLE (and Subtitle) Phase I Inspection Report Wright Lake Dam Lower Hudson River Basin, Rensselaer County, N.Y. Inventory No. 757		5. TYPE OF REPORT & PERIOD COVERED Phase I Inspection Report National Dam Safety Program

**LOWER HUDSON RIVER BASIN
CITY OF TROY
RENSSELAER COUNTY, NEW YORK**

**WRIGHT LAKE DAM
NY 00757**

JULY 1981

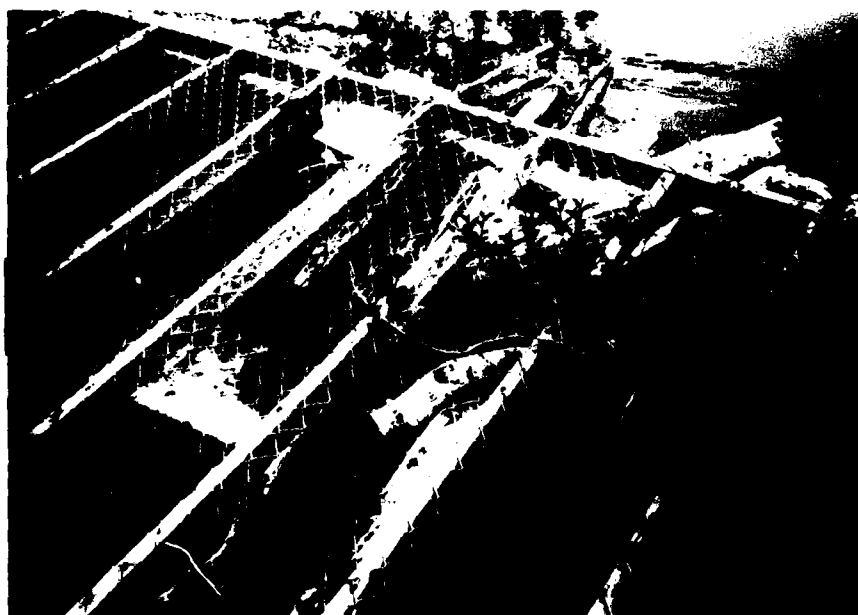
A-6B View of drop inlet weir at location of displaced capstone - 5/6/81
